**Product Type** Single Dryer, Tumble Dryer, Topload Washer, Frontload Washer, Cabinet Hardmount Washer-Extractor (\*C Models)  
**Purpose** Service Procedure  
**Interchangeable** N/A  
**Subject** Coin Drop Not Accepting U.S. Quarters

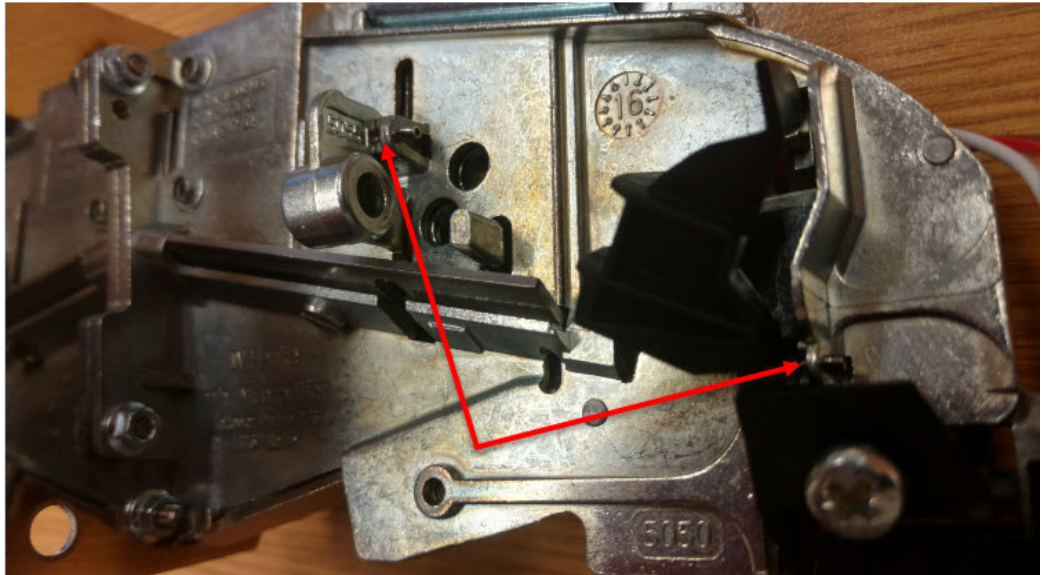
Figure 1

Mechanical coin drops, Part No. 70441601P, not accepting U.S. quarters can be caused by a small casting burr on two areas of the coin drop causing the quarter to be rejected. The small casting burr prohibits both the weight and anti-string pendulum from freely moving.

To correct, remove drop from unit. The slight burr can be removed by applying side to side pressure on the pivot joint while working the part in a back and forth motion. Add one drop of PTFE (such as Teflon™) lubricant and work the lubricant into the joint area. Bench test the drop by inserting quarters to test the operation. Reinstall the coin drop.
